REPORT NO: MT-12/160

LOAD TESTING OF A TOILET BACKREST EGR800 GRABRAIL

CLIENT: **AXESS TRADING PTY LTD**
ATT: RUDI
25/69 ACACIA ROAD
FERNTREE GULLY VIC3156

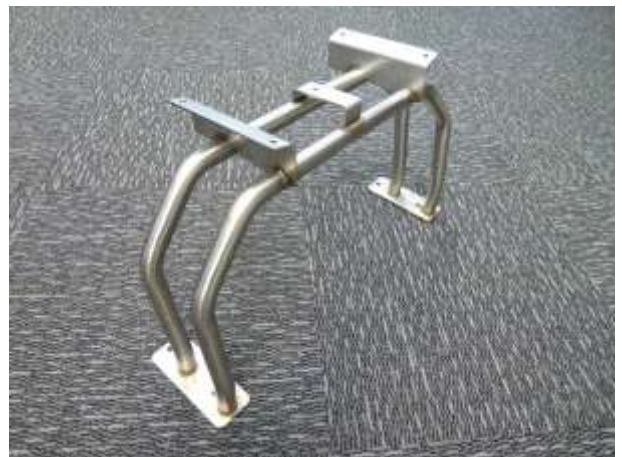
FIG.1.
EGR800 TOILET BACKREST/GRABRAIL

An EGR800 toilet backrest/grabrail assembly was delivered to the MTS laboratory for load testing (see Fig.1). At the request of the client, the grabrail was to be proof load tested in accordance with AS1428.1-2009 DESIGN FOR ACCESS AND MOBILITY. PART 1: GENERAL REQUIREMENTS FOR ACCESS - NEW BUILDING WORK.

Construction details for the backrest/grabrail were provided by the client and are as follows:

- *Tube Diameter OD:* 25.4mm
- *Tube Wall Thickness:* 1.2mm
- *Tube Material:* 304 Stainless Steel
- *Flange connection to plates:* TIG welded

Inspection of the EGR800 toilet backrest/grabrail both during and at completion of loading did not reveal any visible evidence of permanent deformation to the tubular framework, attachments or wall bracket components.

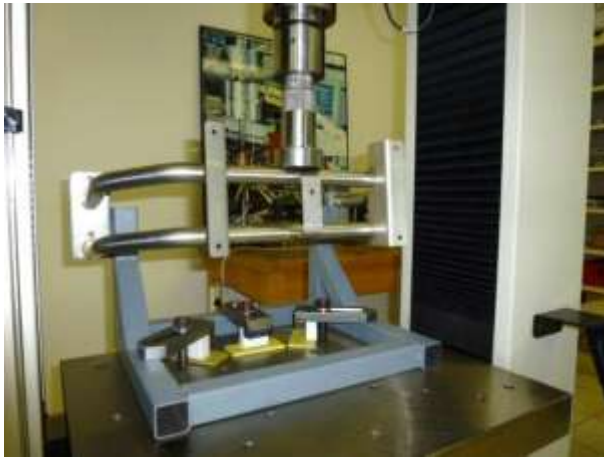
**FIG.2A
MID-SPAN DOWNWARD LOADING**

The backrest/grabrail was fixed to a mounting frame using four (4) M8 bolts. The mounting frame was in turn secured to the base plate of a calibrated universal testing machine (see Fig.2). Load testing was applied in both outward and downward directions and at multiple points on the rail including mid-span as well offset configurations. The position of the load point was selected on the basis of applying the worst case loading condition.

In accordance with AS 1428.1-Clause 17(c), load was applied at a constant rate until a force of 1100 Newtons \approx 112kg was achieved. The application of load was then held constant for 5 seconds before terminating the test.
