REPORT NO: MT-13/727

## **BI – DIRECTIONAL LOAD TESTING OF AN EGT46 DROP DOWN TOILET RAIL**

CLIENT: **AXESS TRADING PTY LTD**  
UNIT 25, 69 ACACIA ROAD  
FERNTREE GULLY VIC 3156

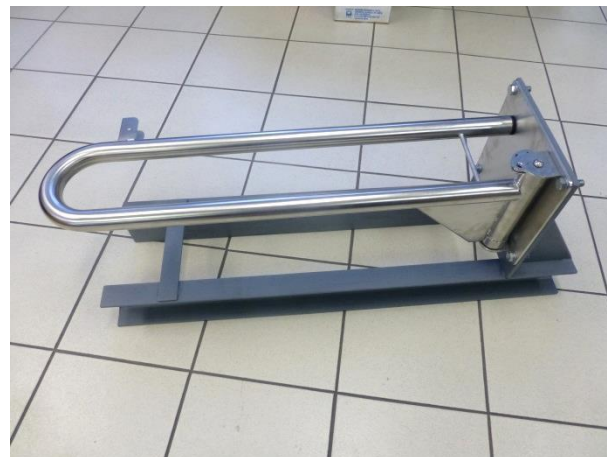
**FIG.1**  
**EGT46 DROPDOWN TOILET RAIL**

An EGT46 dropdown, grab-rail assembly was delivered to the MTS laboratory for load testing (see Fig.1). At the request of the client, the grab rail was to be load tested in accordance with AS1428.1-2009 DESIGN FOR ACCESS AND MOBILITY. PART 1: GENERAL REQUIREMENTS FOR ACCESS - NEW BUILDING WORK.

- *Tube Diameter OD:* 38.2mm
- *Tube Material:* Stainless Steel
- *Flange connection to plates:* TIG welded

The aim of the test was to verify the grab-rails performance in terms of its inherent strength characteristics when tested in both the lateral (see Fig.1) and vertical positions. The scope of the work did not extend to performance attributes of grab-rails installed onto walls of new or existing buildings.

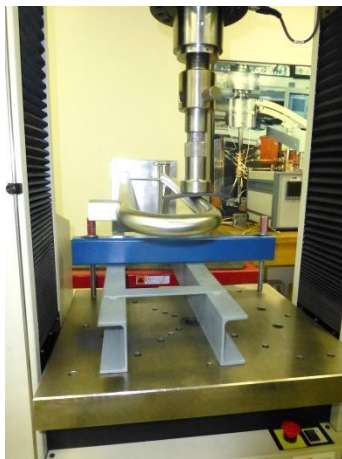
**FIG.2**  
**LATERAL DOWNWARD**  
**LOADING**

The grab-rail was fixed to a mounting frame using four (4) M12 bolts. The mounting frame was in turn secured to the base plate of a calibrated universal testing machine (see Fig.2). Test load was applied in the lateral direction both upward and downward at multiple points on the grab-rail including 450mm and 650mm from the attachment mounting frame. Further tests were conducted on the same points in the vertical position (see Fig.4). A final destructive test was conducted by applying the load at the 650mm load point in the lateral direction.

Inspection of the EGT46 toilet grab-rail, both during and at completion of loading 450mm and 650mm out from the mounting frame when tested in the lateral position, did not reveal any visible evidence of permanent deformation to the tubular framework, attachments or wall bracket components. When tested at the same points in the vertical direction, the **1100N** force was also achieved without failure.

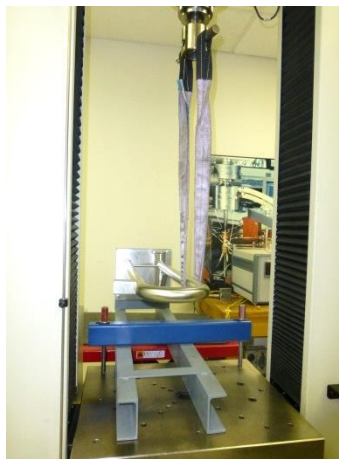
**FIG.3**  
**LATERAL UPWARD**  
**LOADING**

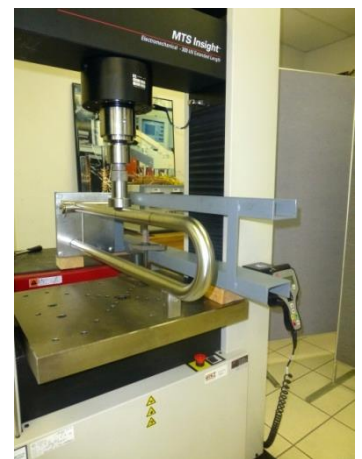
**FIG.4**  
**VERTICAL DOWNWARD**  
**LOADING**
